RAILROAD COMMISSION OF TEXAS

SURFACE MINING AND RECLAMATION DIVISION

RE: San Miguel Electric Coop, Inc.
San Miguel Mine, Permit No. 11G
Final Action Notification, NOV 114A

Statement of Inspector's Observations
Notice of Violation No. 114A
Issued to San Miguel Electrical Cooperative, Inc.
San Miguel Mine, Permit No. 11G

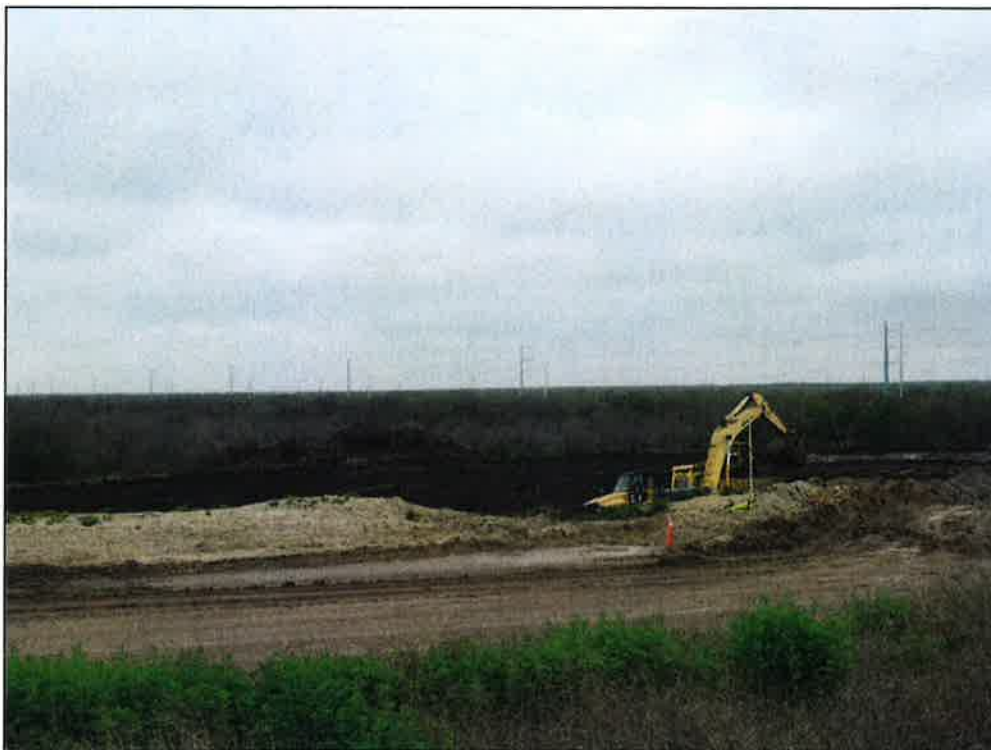
On March 17-18, 2015 I inspected the area affected by the off permit sediment deposition. The affected area is located approximately 2400 feet south of the one lane bridge over La Parita Creek and west of the main haul road (photo 1). The sediment deposition occurred due to failure to maintain the sump on the bottom of Drop Structure No. BN-2 (photo 2). A front end loader was removing the remaining sediment from the affected area using an end dump truck to stage the sediment on the haulroad north of La Parita Creek (photo 3 and 4). The sediment appeared to be composed mostly of haulroad fines which had collected in the sump below Drop Structure No. BN-2 and were deposited north of the haulroad when the sump failed due to lack of maintenance (photo 5). The sediment affected an area of approximately 1.6 acres north of the haulroad (photo 6). The vegetation was removed by dozer and stacked on the western side of the affected area (photo 7).

Photo 1. Affected area located west of the main haul road (view northwest).

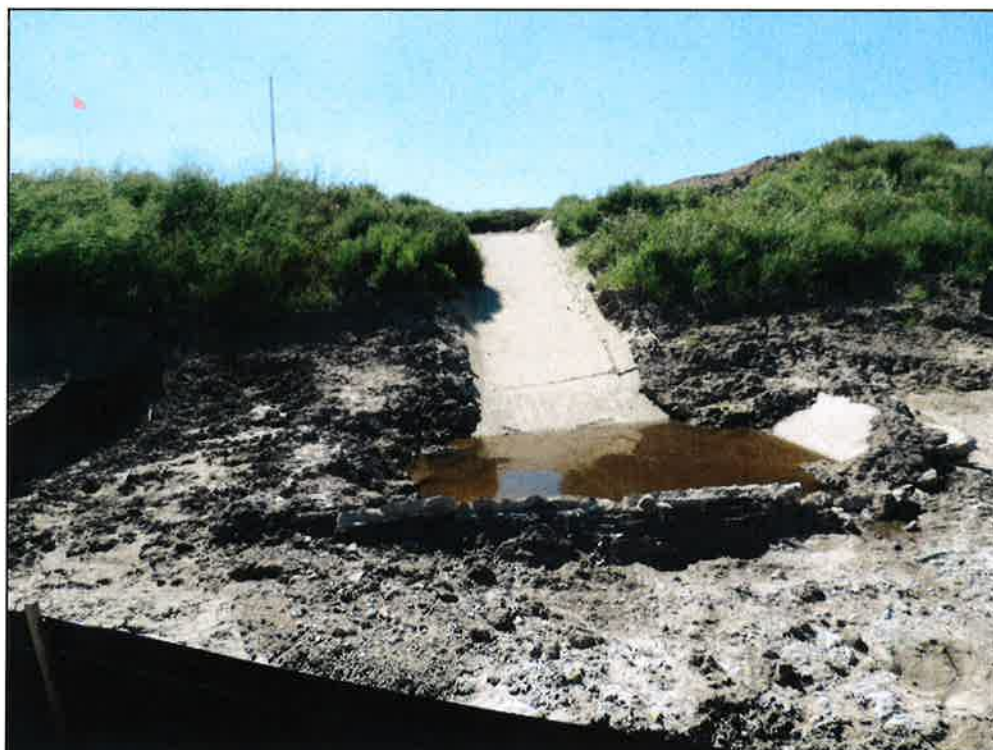
Upon review of the Regulations, Permit No. 11G and discussion with I&E Manager, Notice of Violation 114A was issued to SMECI for failure to maintain appropriate sediment control measures at the sump below Drop Structure No. BN-2. This is a violation of Texas Coal mining Regulations Title 16, Texas Administrative Code §12.343 and section .154 of Permit No. 11G.

Photo 2. Drop Structure No. DN-2 (view southeast).

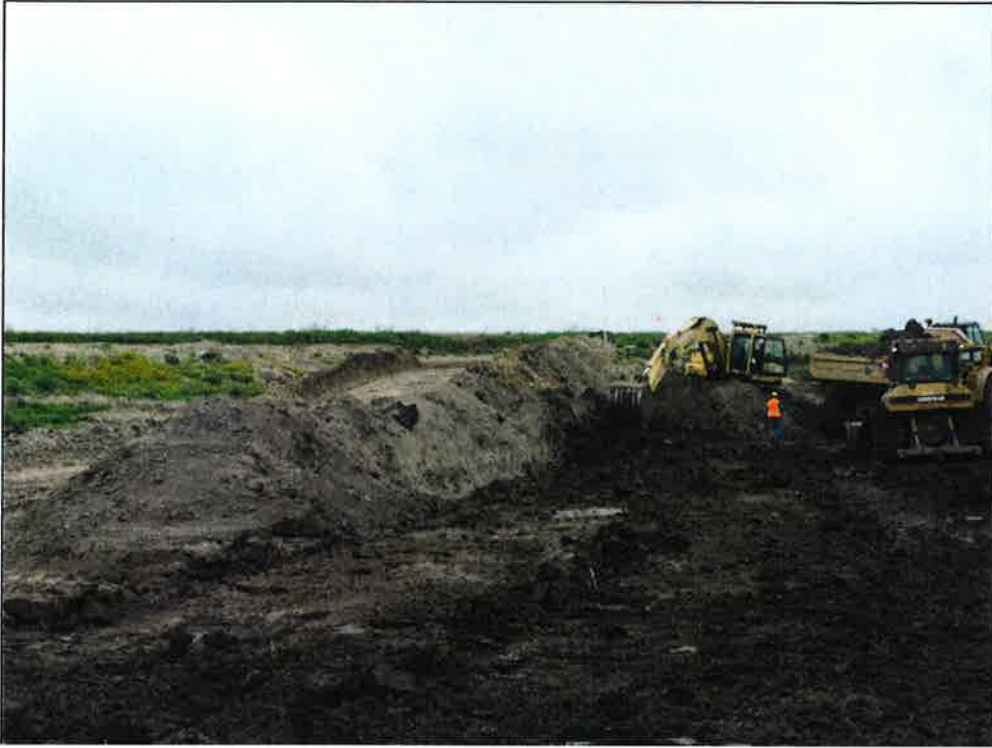
Photo 3. Front end loader removing sediment from affected area (view southwest).

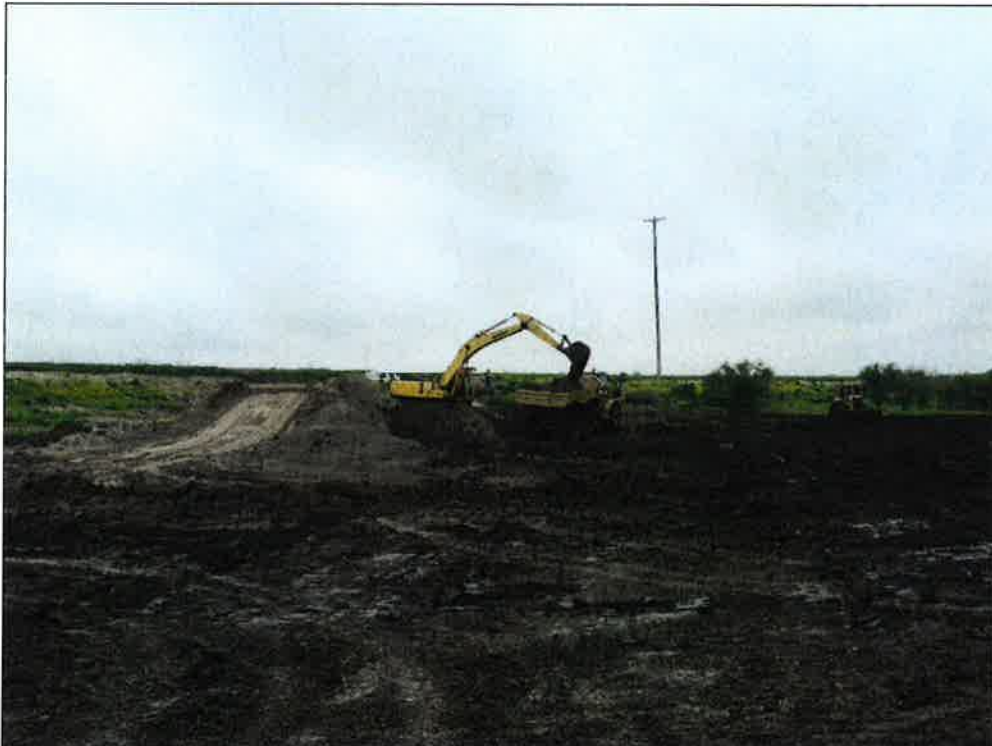
Photo 4. Equipment being utilized to remove sediment (view southwest).

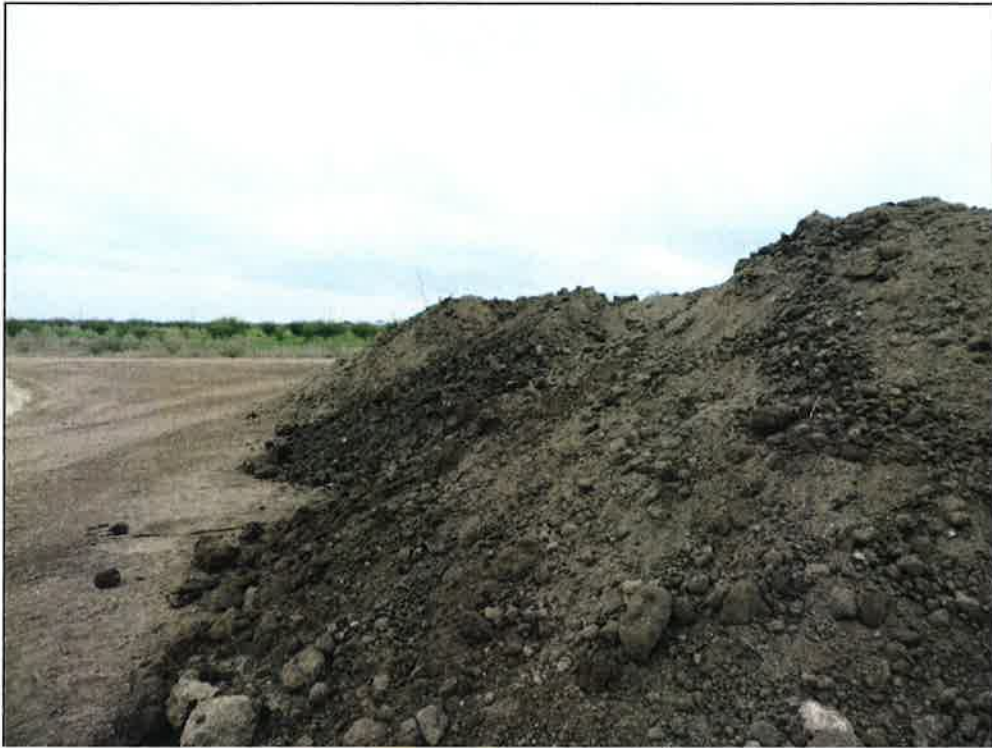
Photo 5. Excavated sediment removed from off permit affected area (view east).

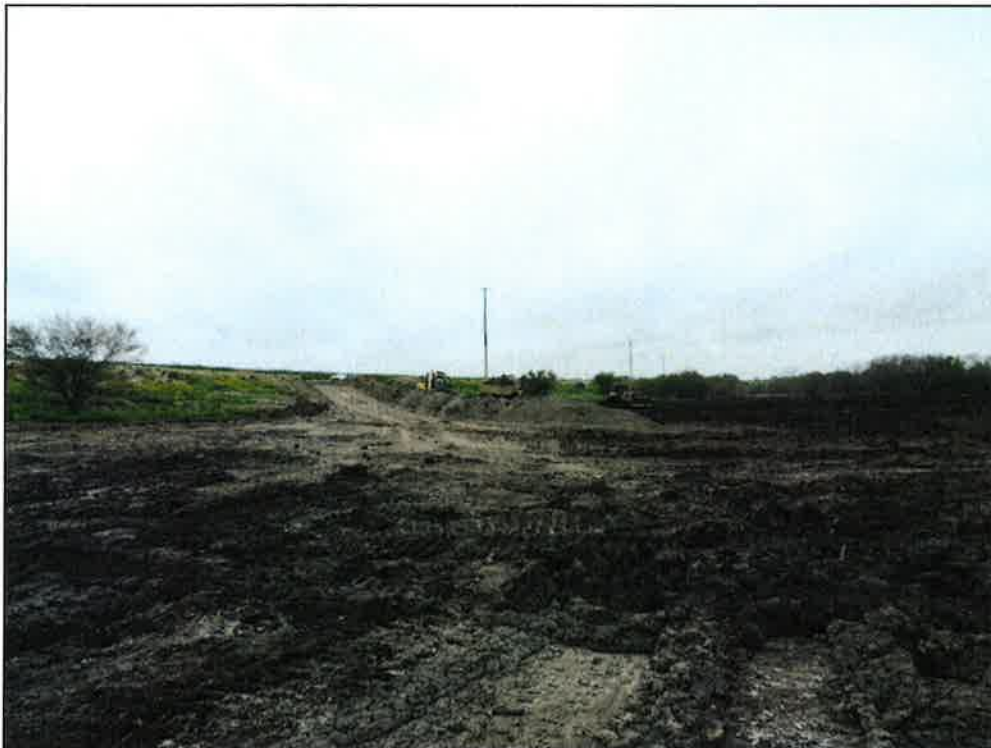
Photo 6. Approximately 1.6 acres were affected by off permit sediment deposition (view southwest).

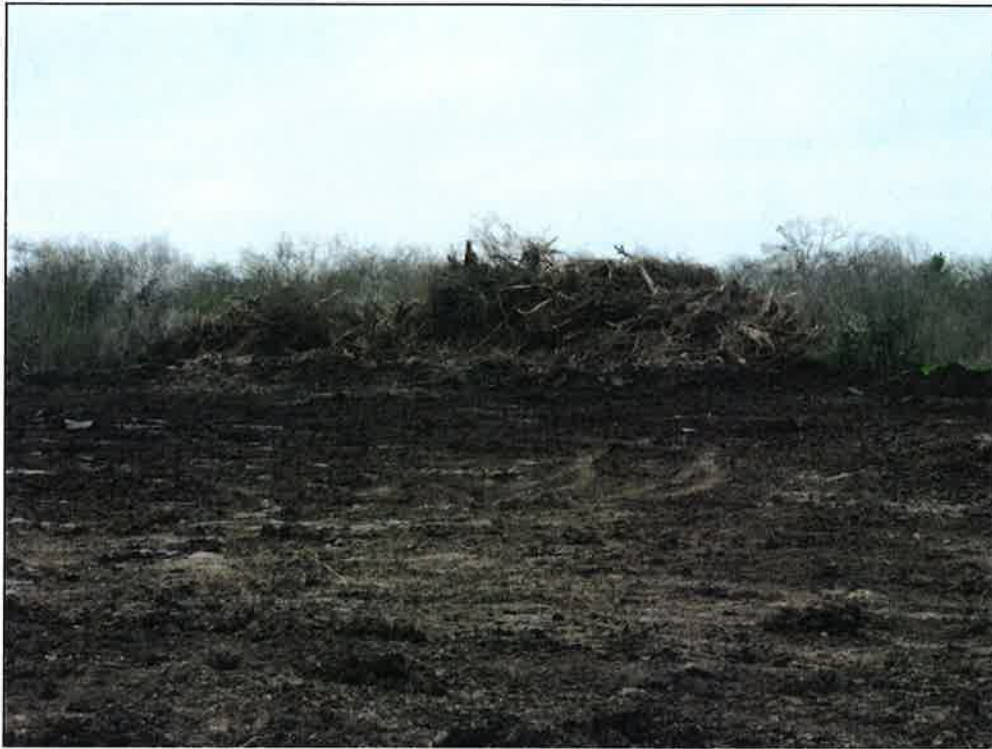
Photo 7. Removed vegetation staged west of the affected area (view north).

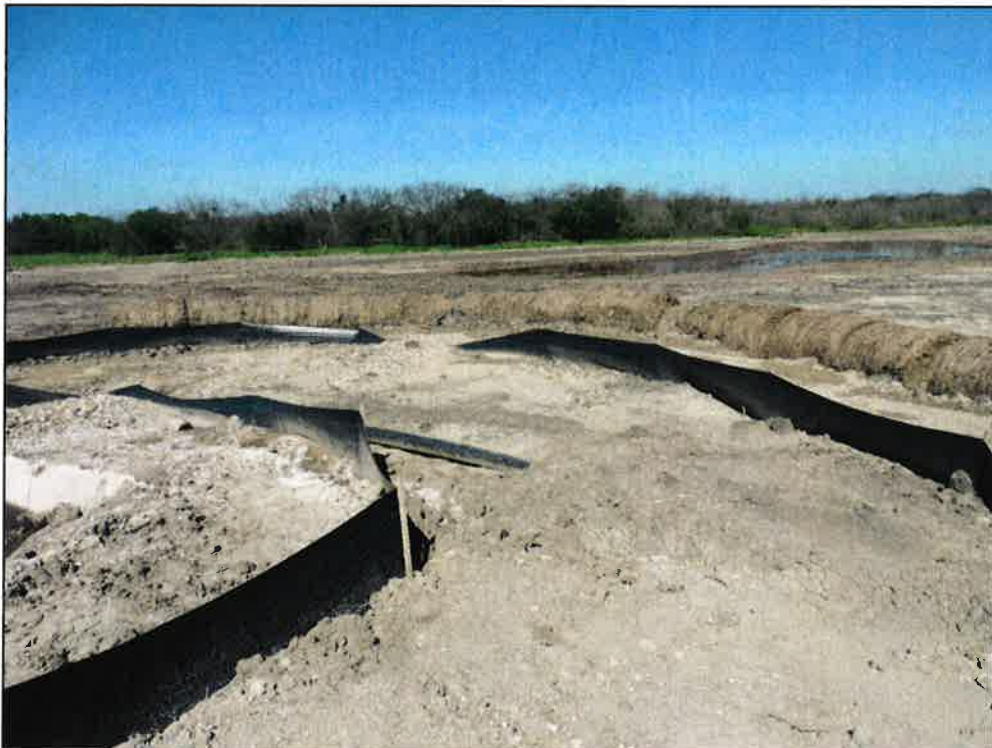
During my inspection on April 28-29, 2015, SMECI utilized silt fence and round hay bales to prevent further sediment deposition (photo 8). The round bales were trenched in place to prevent them from moving. The sump below Drop Structure No. BN-2 had been cleaned of debris and sediment. All sediment and vegetation was removed from the affected area (photo 9 and 10). In a follow up email with Nellie Frisbee dated May 7, 2015, all silt has been removed from the area and it was seeded for revegetation.

Photo 8. Silt fence and hay bales being utilized to prevent further sediment deposition (view northwest).

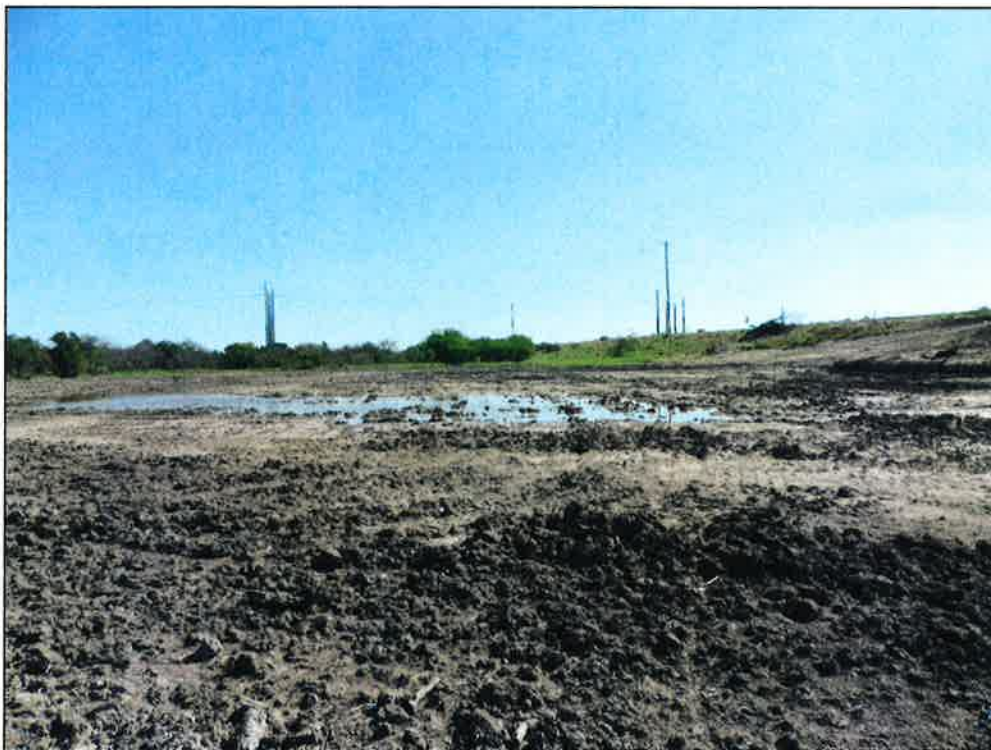
Photo 9. Sediment and vegetation has been removed from affected area (view northeast).

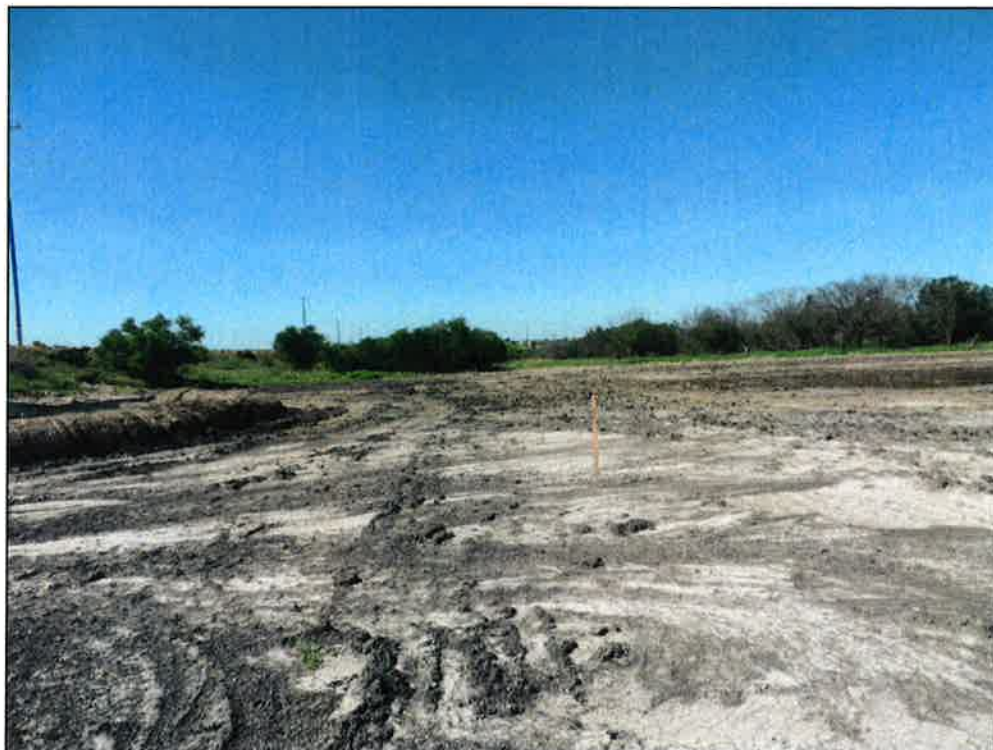
Photo 10. Affected area is now clear of vegetation and sediment (view southwest).

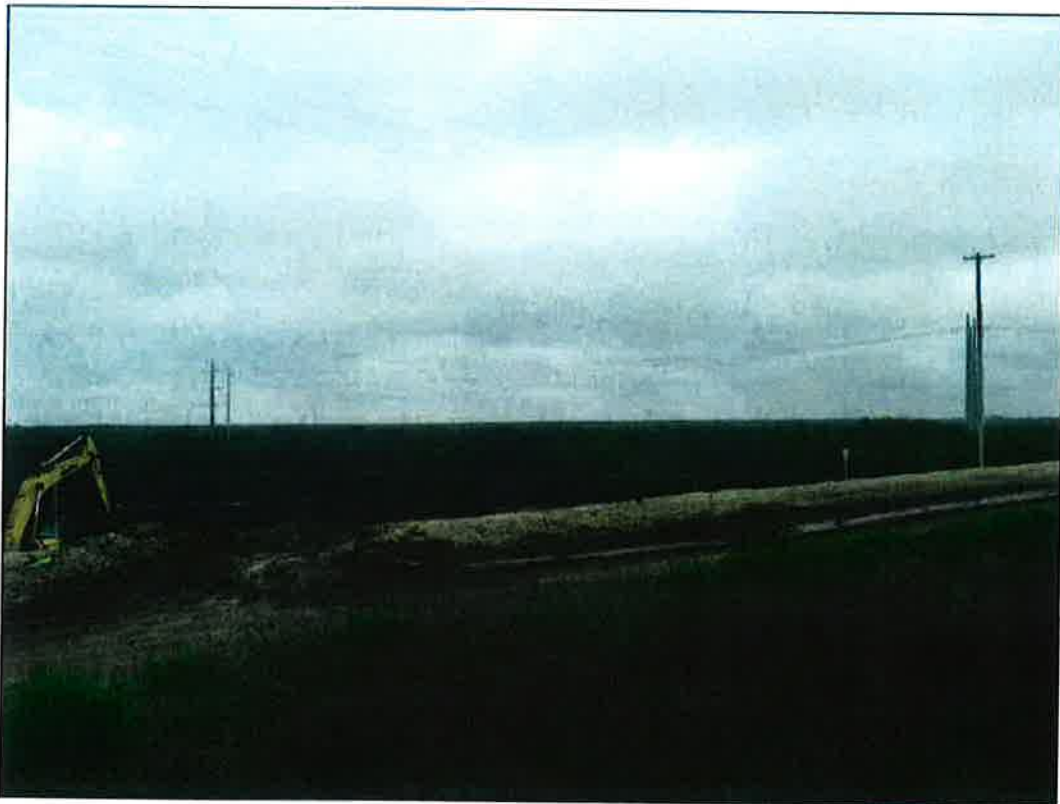
Description of Violation(s): Failure to maintain appropriate sediment control measures. Sediment overflowed the sump along the haulroad because SMECI failed to properly maintain the sump. Therefore sediment was deposited off the permit in an area encompassing approximately 1.6 acres.

Photo 4. Area of disturbance from sediment located west of the main haul road (view northwest).

Remedial Action Required: Remove sediment from the affected area and revegetate the area.

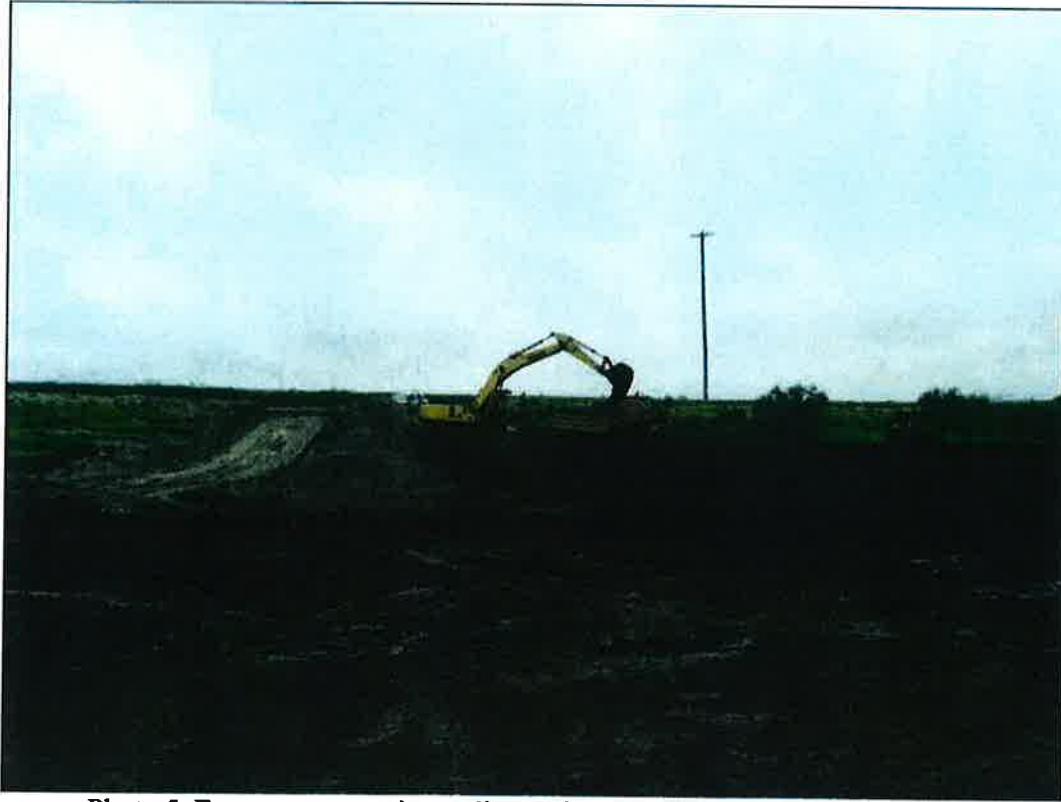
Photo 5. Excavator removing sediment from the disturbed area (view east).

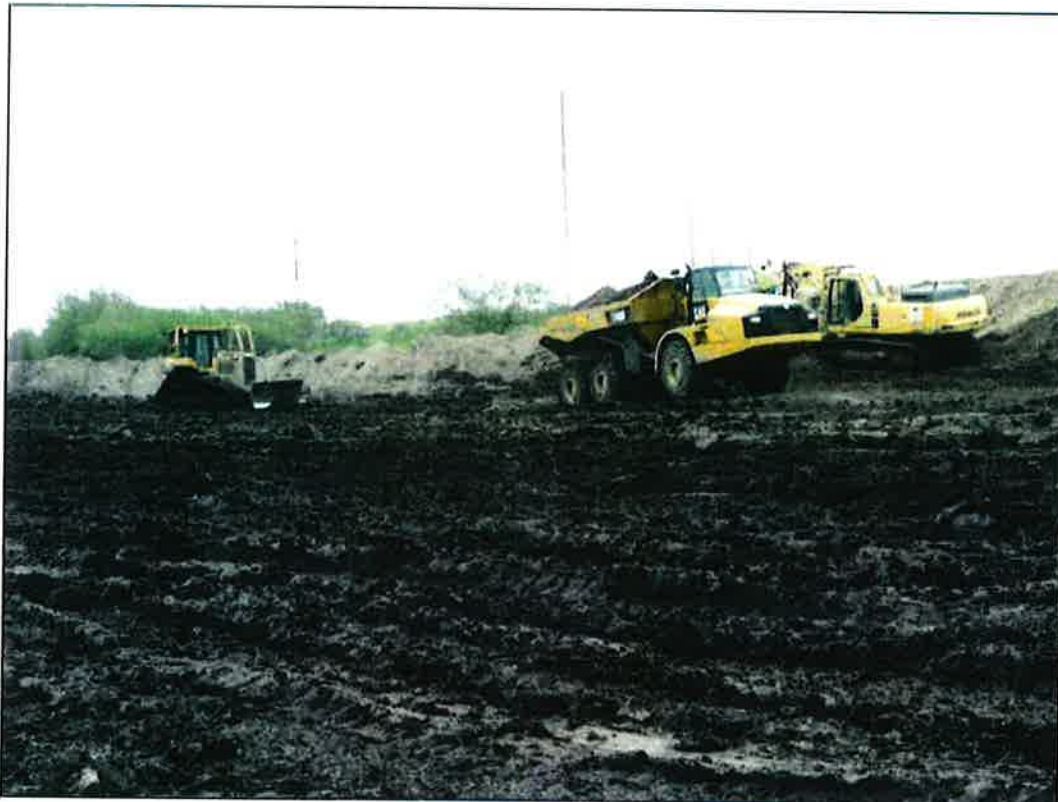
Photo 6. Equipment removing sediment in the disturbed area west of the haul road (view north).

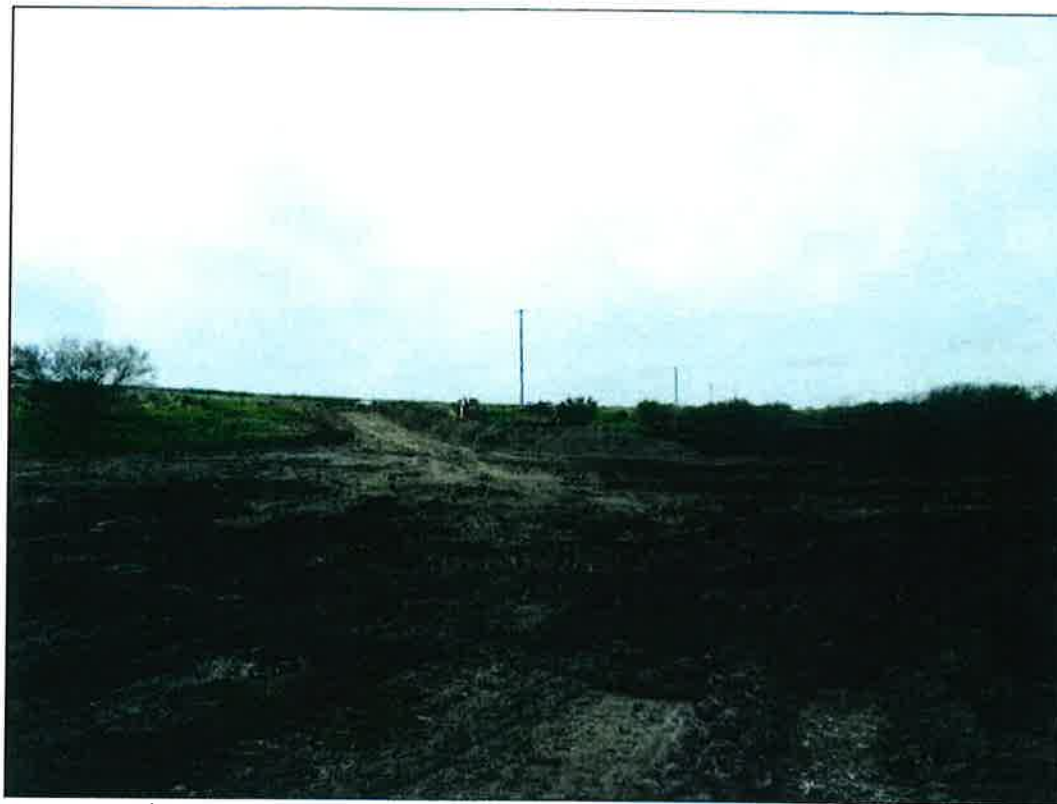
Photo 7. Sediment being removed from disturbed area (view south).

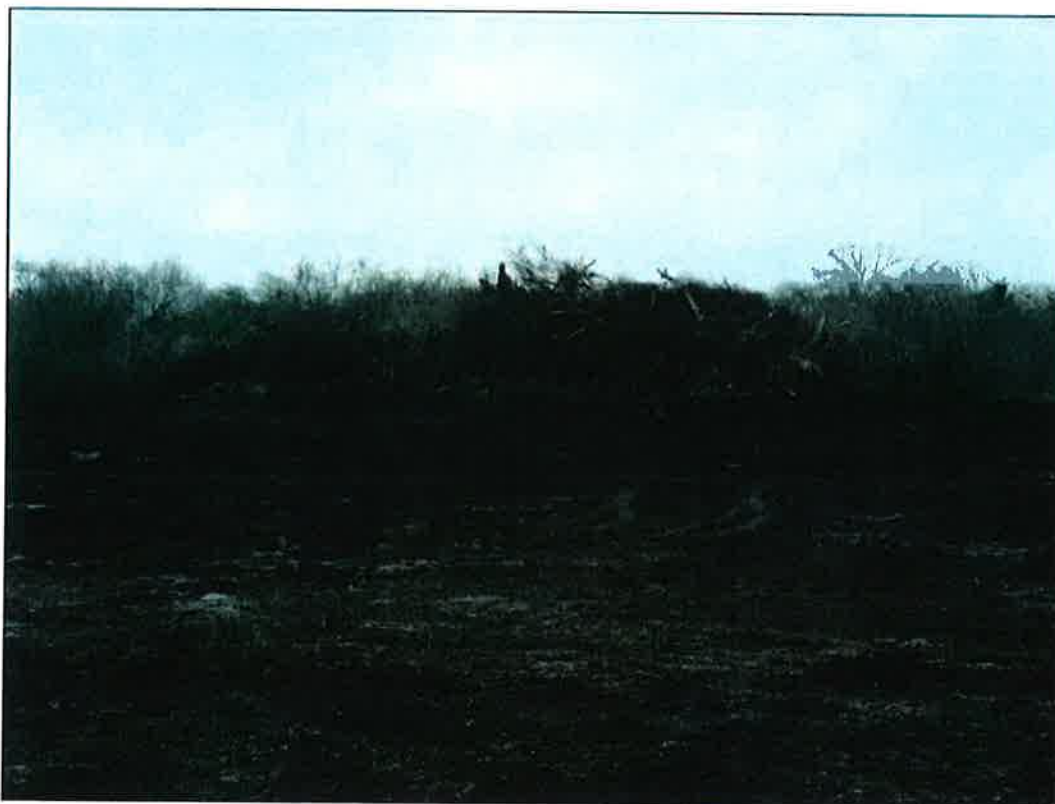
Photo 8. Vegetation removed by dozer and staged on the western side of the disturbance for removal (view southwest).

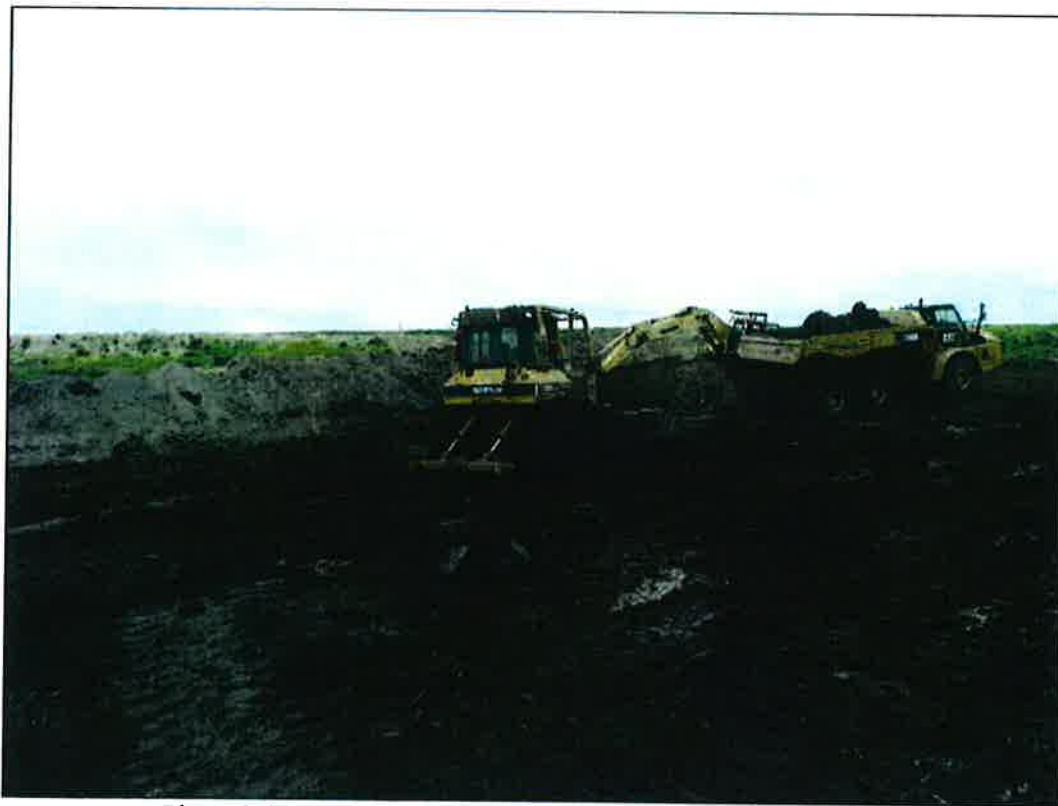
Photo 9. Dozer being utilized to level the topsoil (view south).

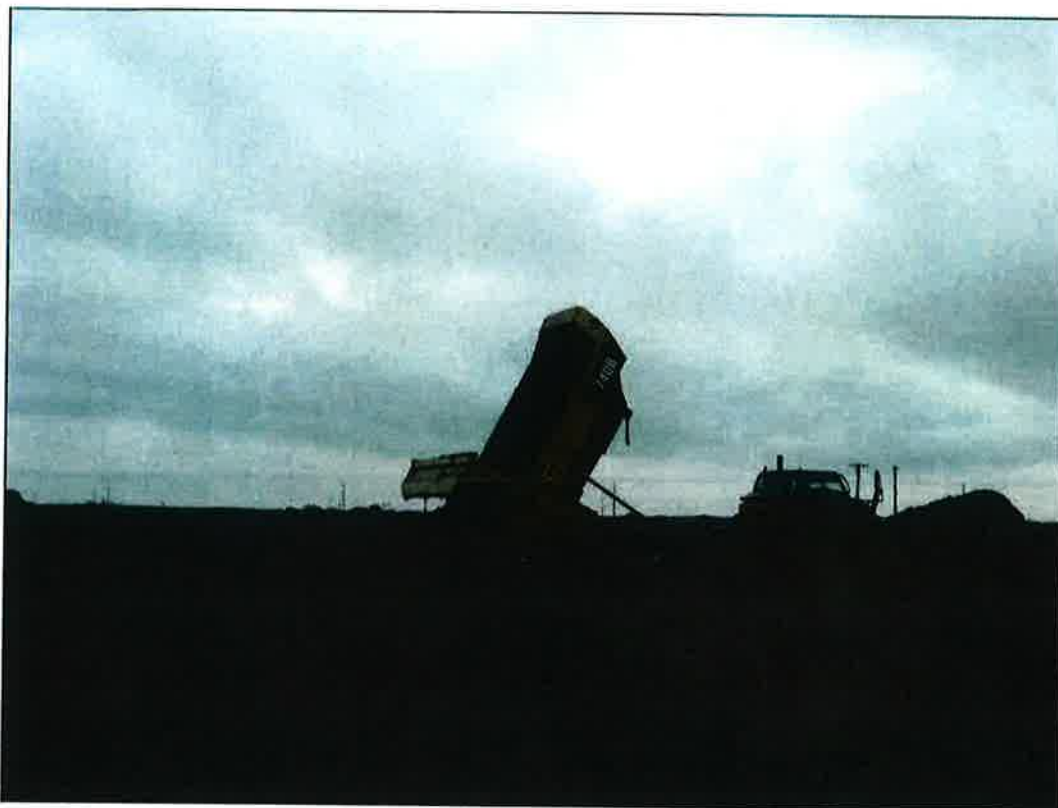
Photo 10. Sediment from the disturbed area being staged at the junction of the haulroads north of the one lane bridge (view south).

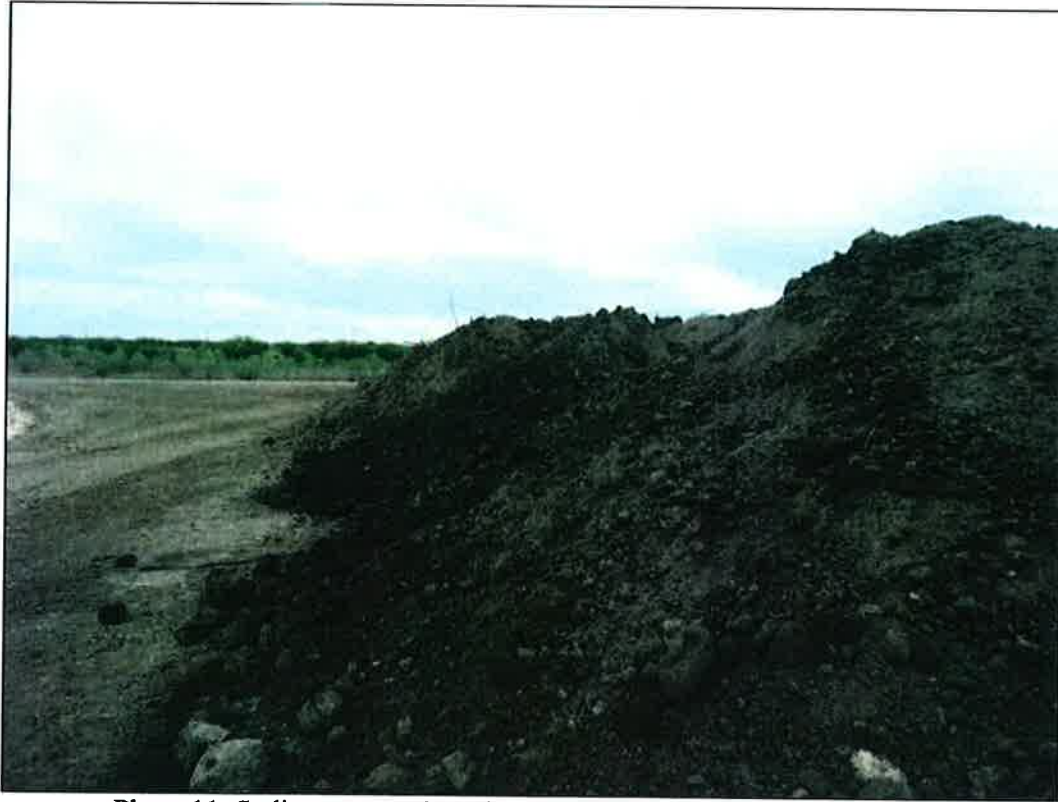
Photo 11. Sediment staged on the junction of the haulroad (view east).

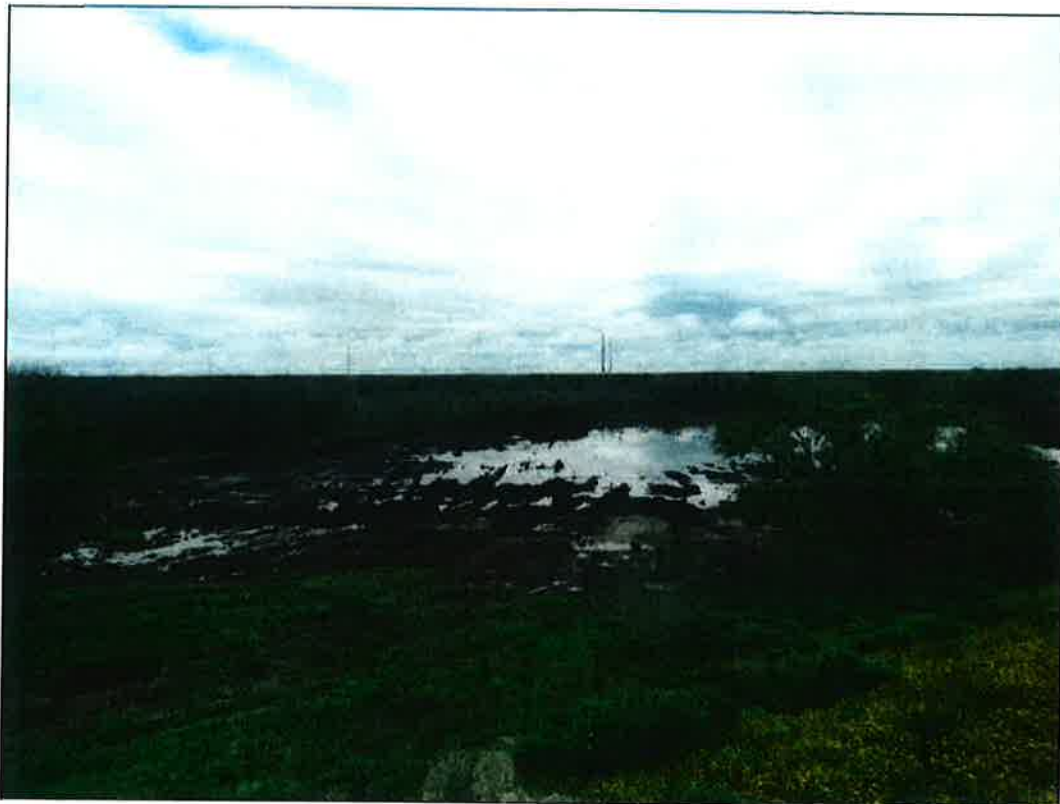
Photo 12. Disturbed area with waterlogged conditions of March 18, 2015 (view west).
